Date: July 12, 2021 Project Number: 19-009

Subject: 301 Mission Retrofit Monitoring Report 010: Results as of July 9, 2021

CONTEXT

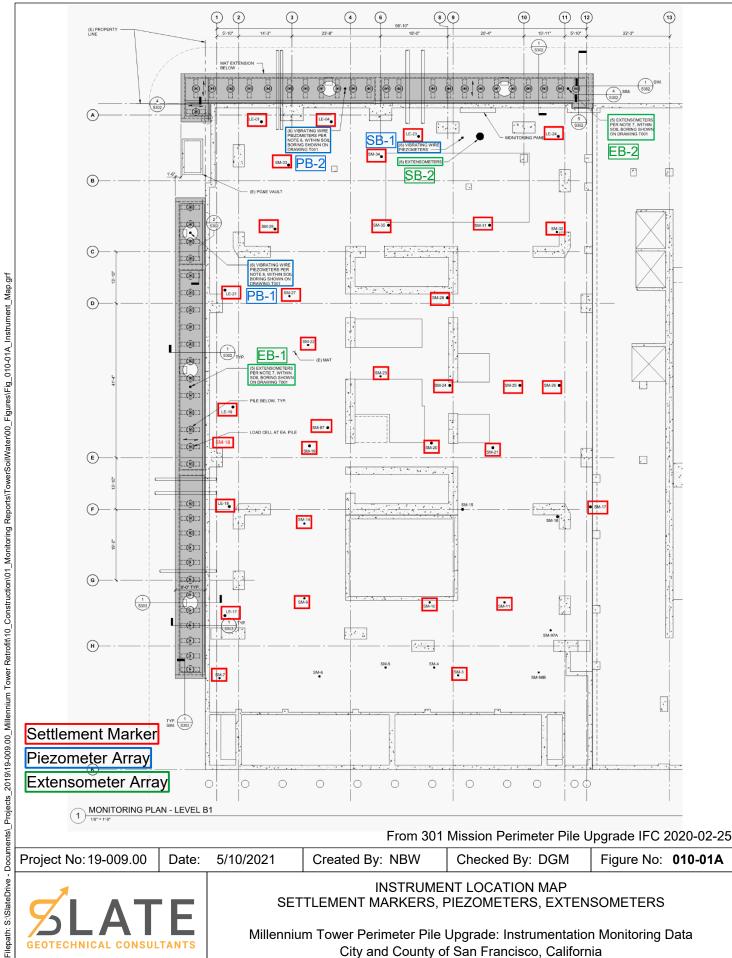
Created By: NBW Checked By: DGM Figure No: **010-01A**

Figure 01 presents the instrument locations as referenced in later figures.

INSTRUMENT LOCATION MAP SETTLEMENT MARKERS, PIEZOMETERS, EXTENSOMETERS

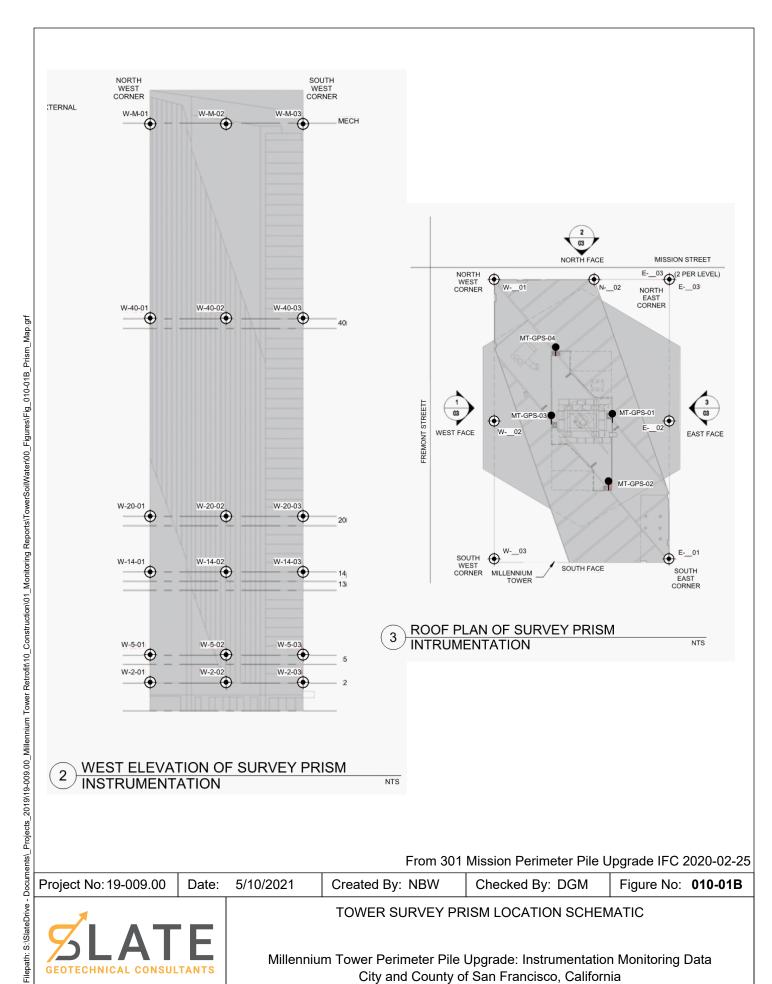
Project No: 19-009.00 5/10/2021 Date: Created By: NBW Checked By: DGM Figure No: 010-01B

TOWER SURVEY PRISM LOCATION SCHEMATIC

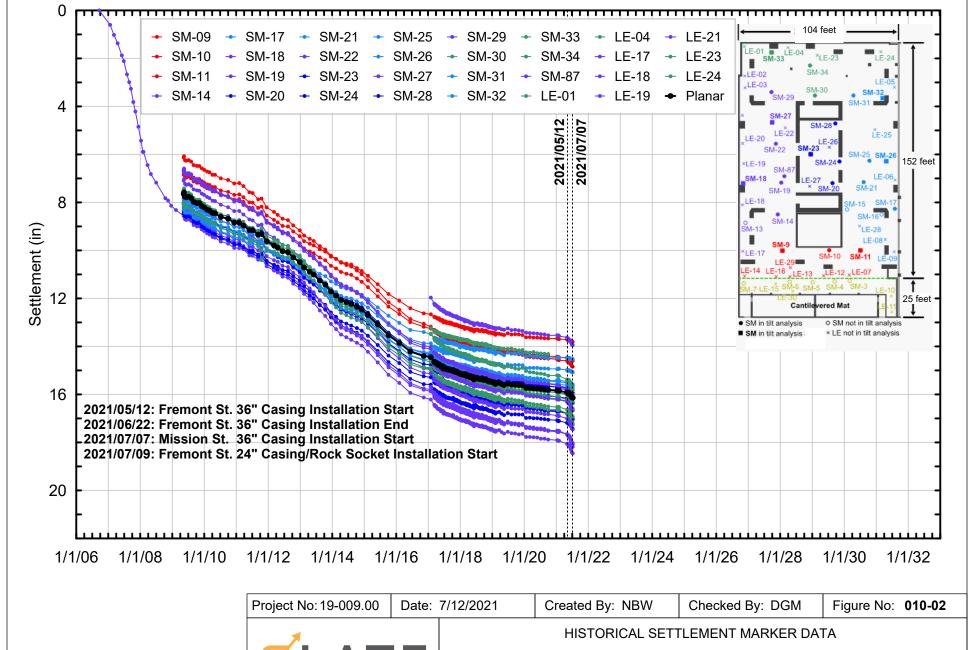
Figure 02 presents the historical settlement data interpreted from settlement markers installed on the B-1 Level of 301 Mission Tower. In addition, data from surveys performed during the retrofit are included. Figure 03 presents differential settlement data since the start of production pile installation (May 12, 2021; baseline readings on May 10, 2021) through July 8, 2021. Figure 04 presents current differential settlement contours (in inches) on July 8, 2021.

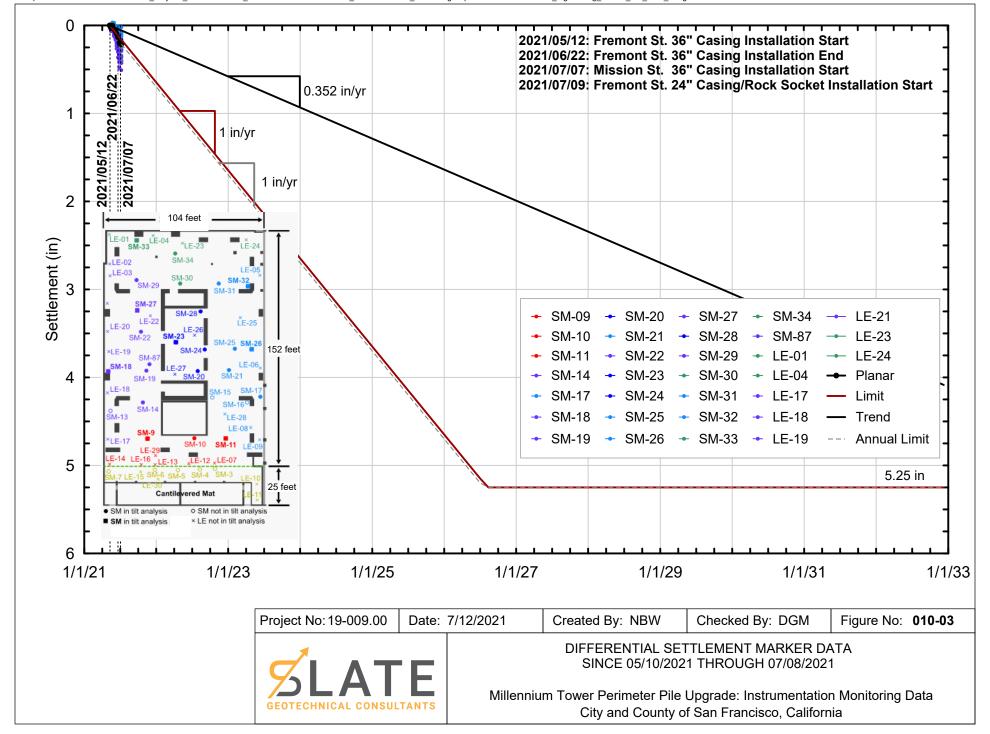
- Figure 03 Differential Settlement Marker Data since 05/10/2021 through 07/08/2021
- Figure 04 Differential Settlement Contours since 05/10/2021 through 07/08/2021

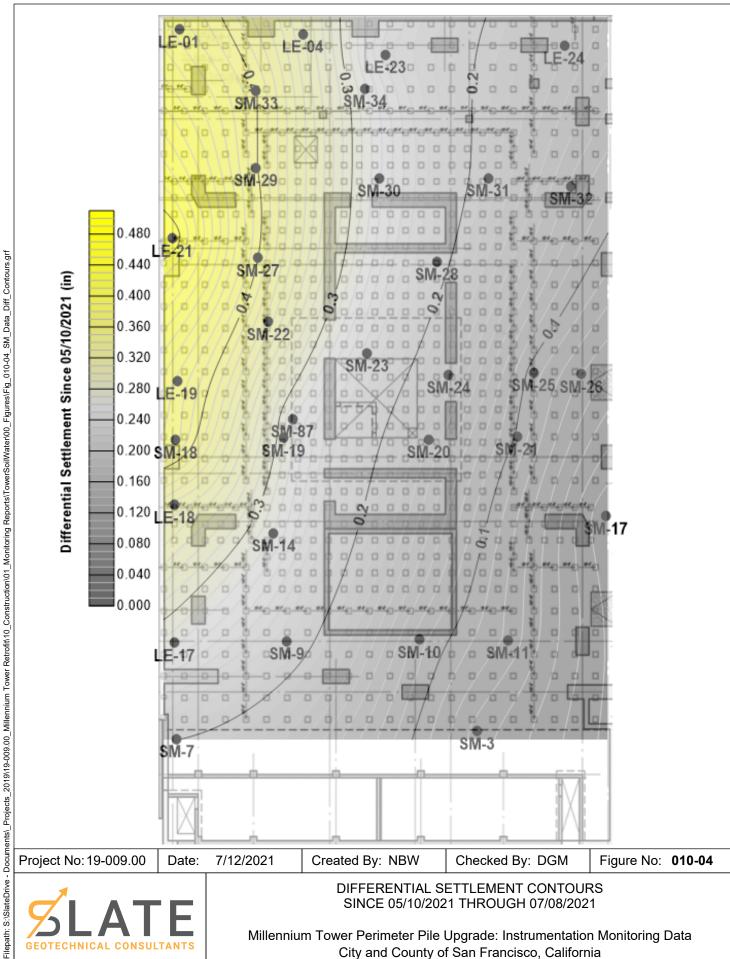
DIFFERENTIAL SETTLEMENT CONTOURS SINCE 05/10/2021 THROUGH 07/08/2021

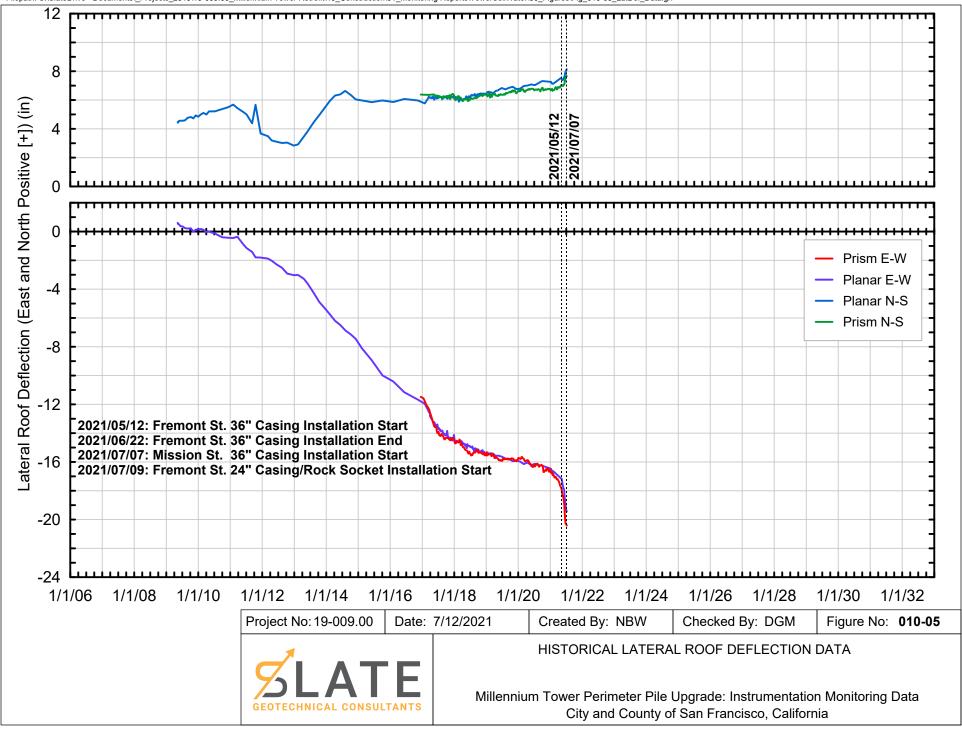
Figure 05 presents historical lateral roof deflections in the project north-south and project east-west directions interpreted from survey prisms mounted on the exterior of the Tower, from InSAR data, and from a planar fit of the settlement marker data. In addition, data from survey performed during the retrofit are included. Figure 06 presents differential lateral roof deflection data from a planar fit of the settlement marker data and from survey prisms mounted on the exterior of the Tower since the start of production pile installation (May 12, 2021; baseline readings on May 10 and 13, 2021, respectively) through July 9, 2021.

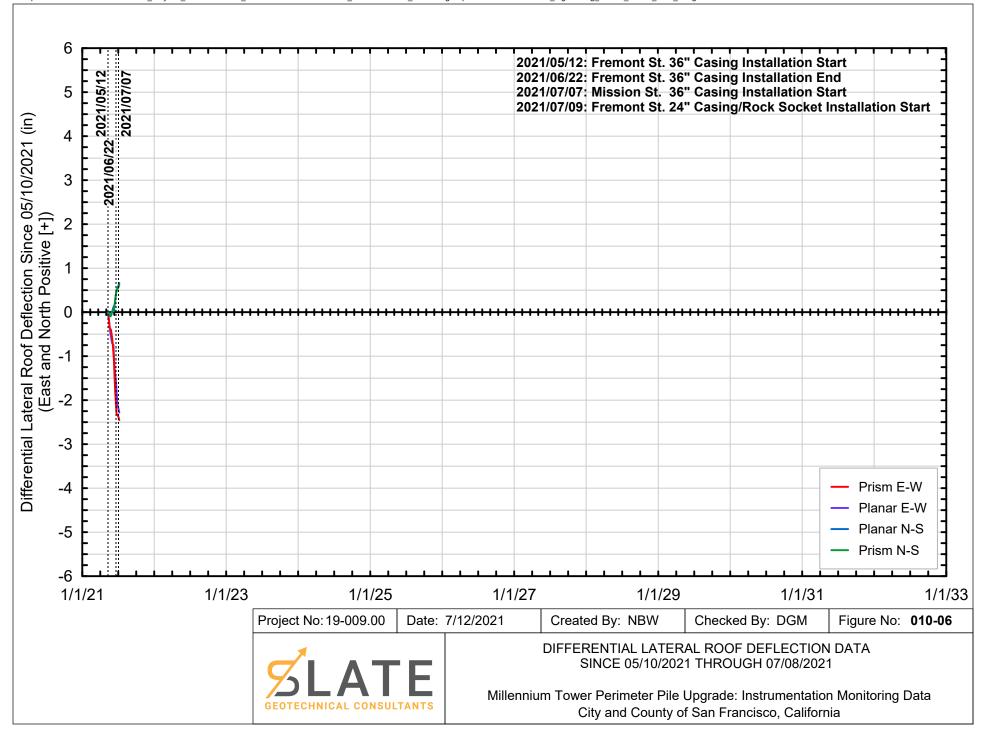
- Figure 05 Historical Lateral Roof Deflection Data
- Figure 06 Differential Lateral Roof Deflection Data since 05/10/2021 through 07/08/2021
- Figure 07 Historical Groundwater Elevation Measurements at Locations Near 301 Mission

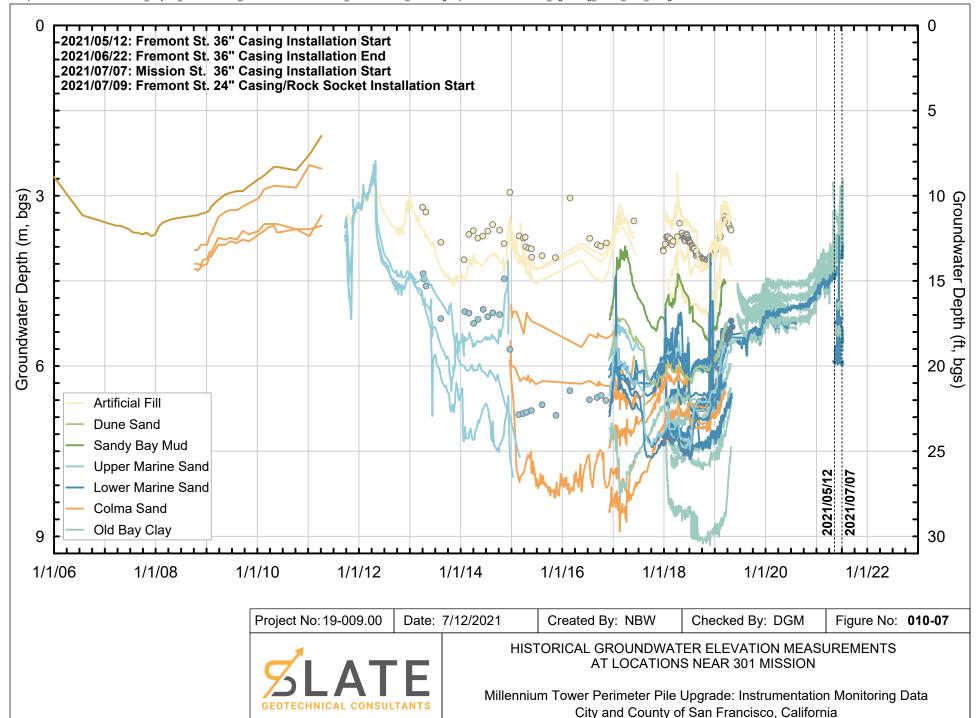
Figure 07 presents the historical groundwater elevation interpreted from piezometer readings at locations near 301 Mission. In addition, data from piezometers installed to monitor groundwater elevation during the retrofit are included. Figures 08 and 09 present groundwater elevation interpreted from piezometer readings in the Marine/Colma Sand and the Old Bay Clay, respectively, for the time period prior to the start of production pile installation (January 1, 2021) through July 9, 2021.

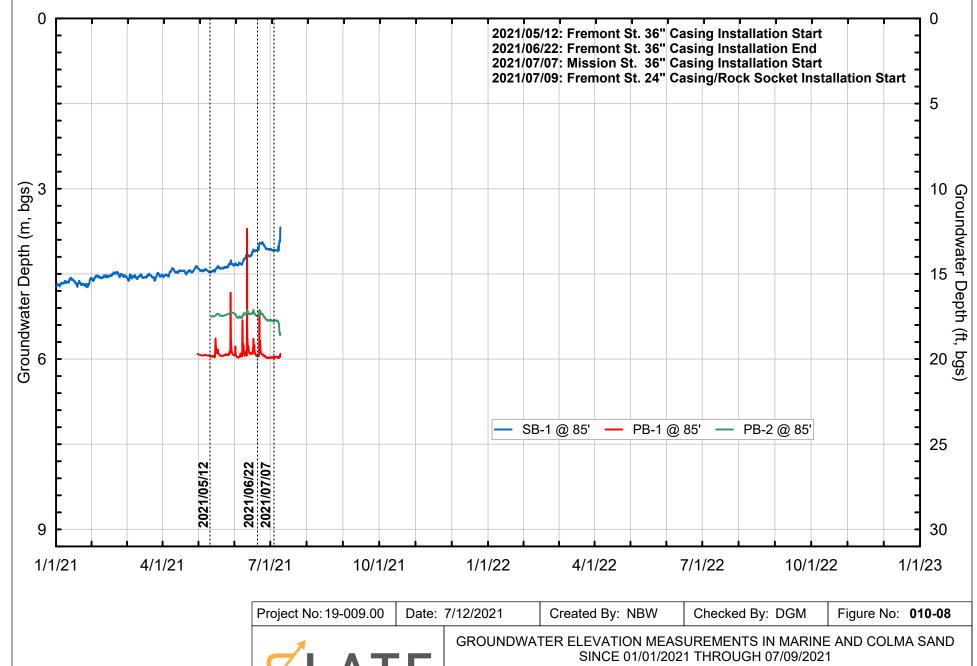
- Figure 08 Groundwater Elevation Measurements in Marine and Colma Sand since 01/01/2021 through 07/09/2021
- Figure 09 Groundwater Elevation Measurements in Old Bay Clay since 01/01/2021 through 07/09/2021

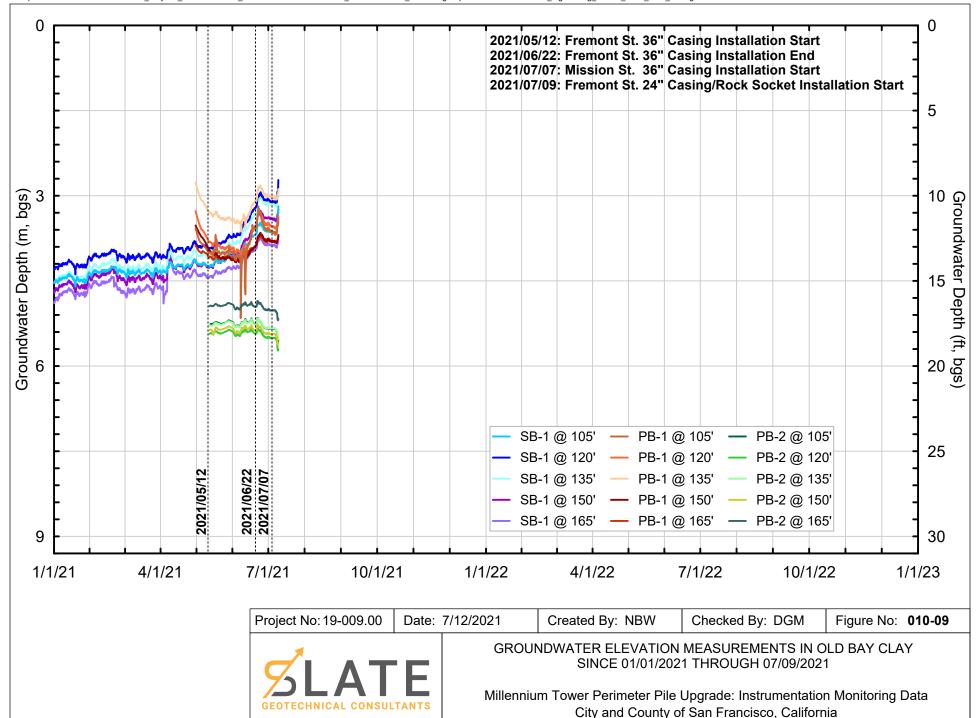
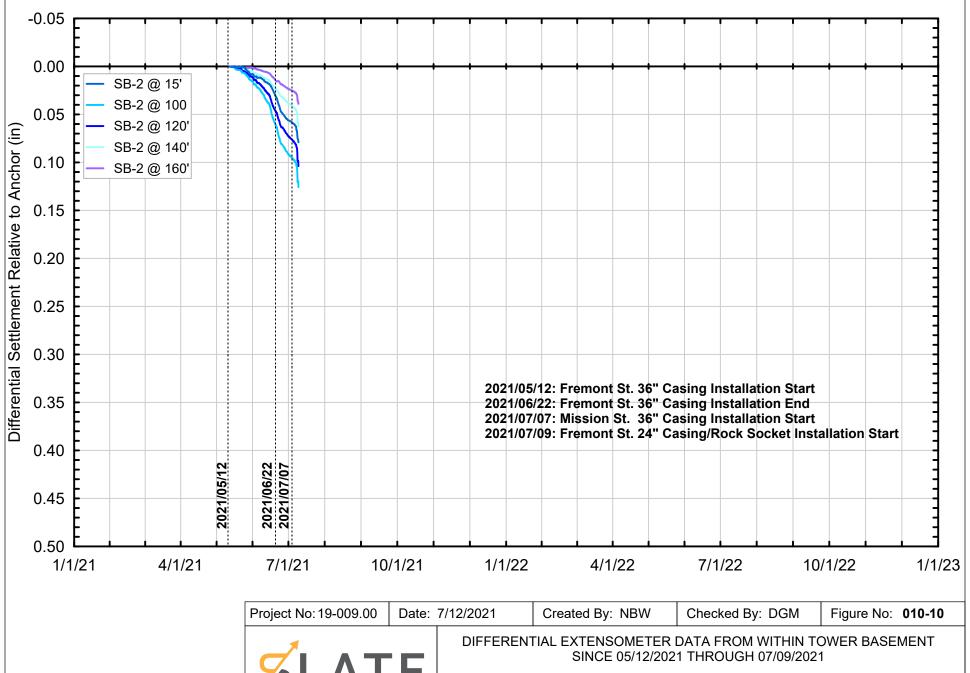
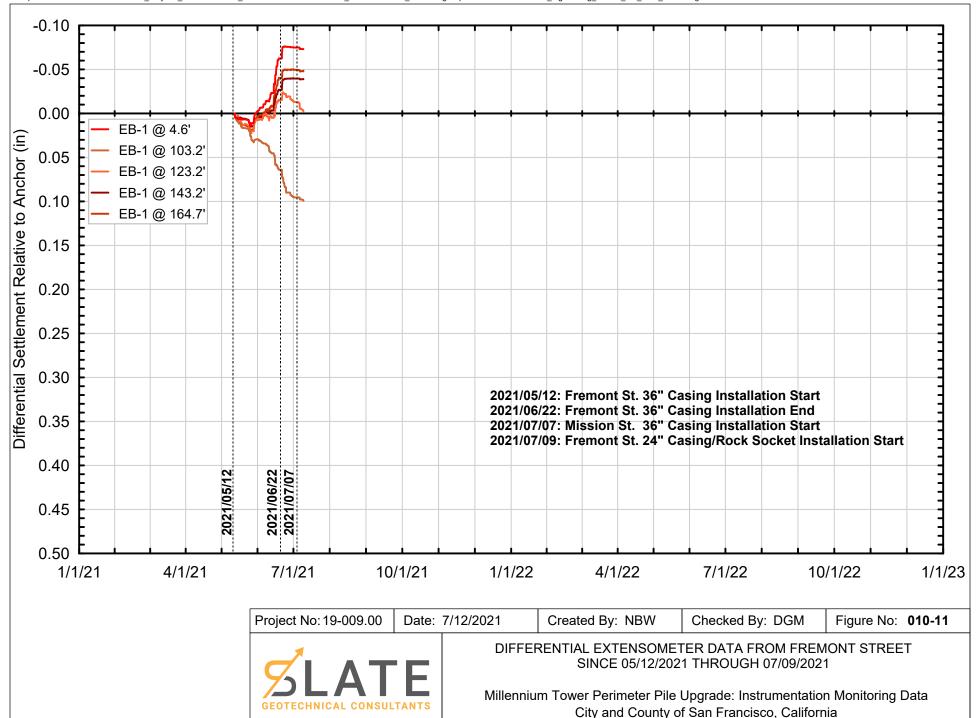
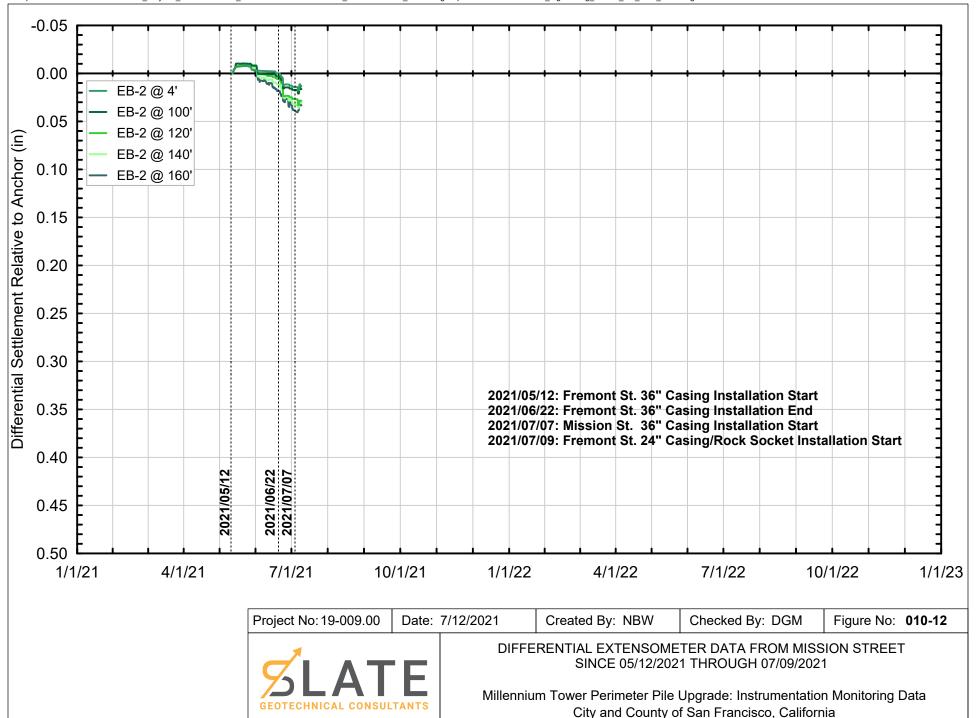
Figure 10 presents extensometer data from within the Tower basement since the start of production pile installation (May 12, 2021) through July 9, 2021. Figure 11 presents extensometer data from Fremont Street since the start of production pile installation (May 12, 2021) through July 9, 2021. Figure 12 presents extensometer data from Mission Street since the start of production pile installation (May 12, 2021) through July 9, 2021.

- Figure 10 Extensometer Data from within Tower Basement since 05/12/2021 through 07/09/2021
- Figure 11 Extensometer Data from Fremont Street since 05/12/2021 through 07/09/2021

- Figure 12 Extensometer Data from Mission Street since 05/12/2021 through 07/09/2021
